# Manhole Inspection Summary

Manhole # S31G\_\_014MH

Insp Date: **8/1/08 10:06 AM**

**Location** Address: **400 w redwood st**

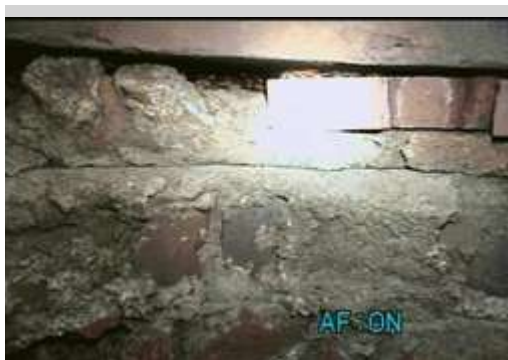
Defect 2

Condition: ☐ Sound ☐ Cracked ☐ Root Intrusion ☒ Loose Brick ☒ Deteriorated

chimney loose bricks and deteriorate,  
frame adj

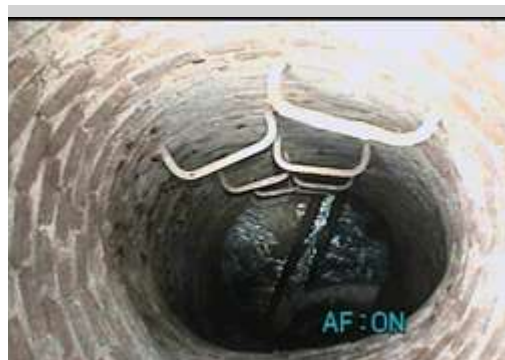
Defect 1

Count: **7** Missing: **0** ☒ Corroded

corroded steps

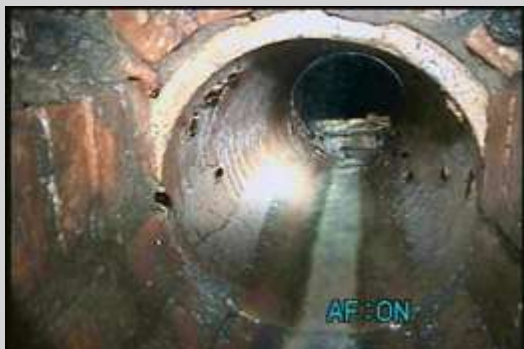
6 O'Clock Inflow

Deposits: ☐ None ☐ Mud ☐ Sludge ☒ **Debris** ☐ Grease

Silt Depth: **2.5** (in.) Deposits Extent: **Light**
